HOME SAFE & SOUND
Home Inspection

Building Inspection Report

#123 Your Address

Inspection Date:
May 10, 2010

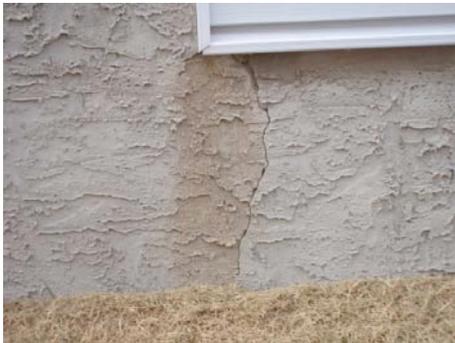
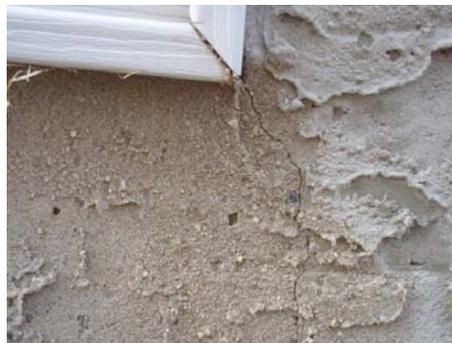
- **Monitor:** Common minor settlement cracks were observed in the foundation walls along the north side of the house. This implies that some structural movement of the building has occurred. Cracks of this type should be watched for any sign of additional movement. In the absence of any sign of ongoing movement, repair should not be necessary.

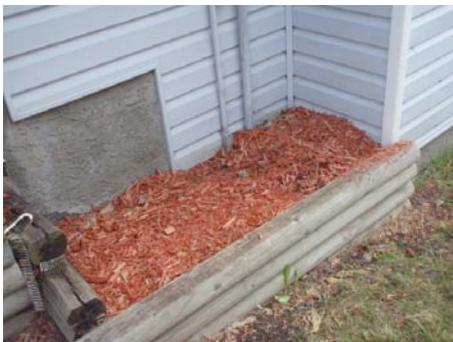
- **Repair:** The height of the backfill (soil adjacent to the foundation) is above the top edge of the foundation and is against the siding and framing. This could cause seepage into your house and the framing and siding to rot over time. The ground level must be lowered to below the framing material.

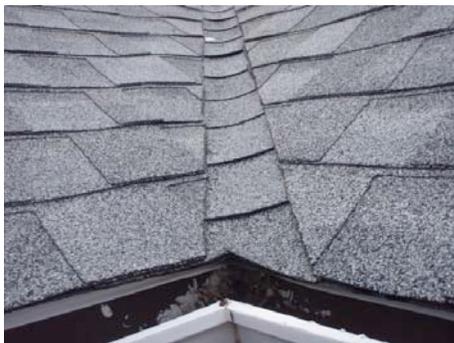
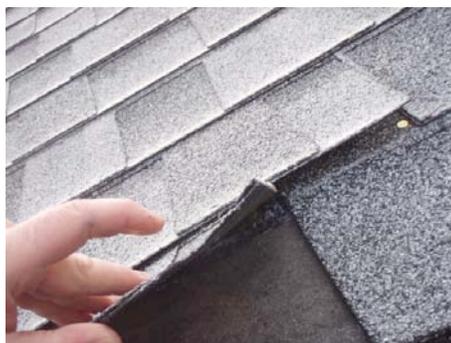
- **Monitor: Repair:** The roofing is in fair condition but has been installed using poor workmanship. While this condition does not pose a serious short-term concern, it risks leaks and shorter roof life. The starter row should be installed with the aggregate side up
- **Monitor: Repair:** The installation of the roofing system is such that several vulnerable areas may exist. There is a higher potential for leaks. The valleys have been installed a new way and may be vulnerable. Further investigation may be needed. Roofing installation must follow recommended standards approved by the Alberta building code

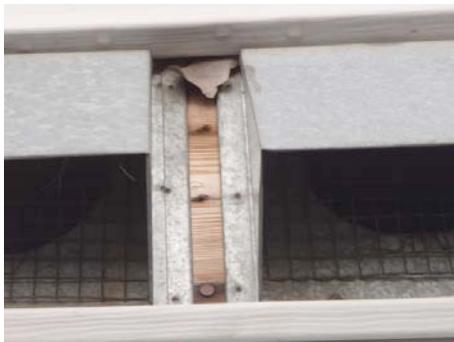
- **Repair:** Missing vinyl siding at the east side of the home between vents should be completed to preserve the building envelope. There is risk of hidden damage in such areas from prior water entry.

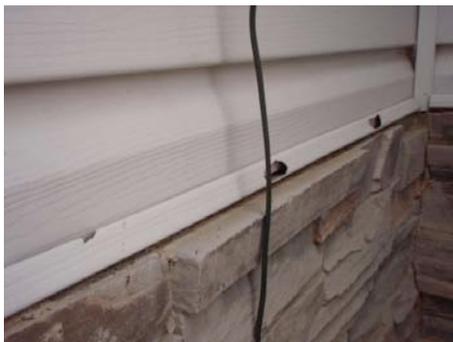
- **Monitor: Repair:** The stone sills slope towards the house at the west side of the home. Repair/replacement of the sills is usually not practical unless replacing the stonework. In the interim, the sills should be kept caulked.

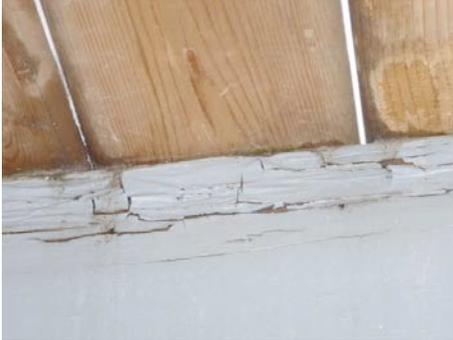
- **Monitor:** The garage floor slab has typical cracks usually the result of shrinkage and/or settling of the slab. Cracks more than 1/8" high could present a trip hazard.
- **Monitor:** The deck at the east side of the home shows evidence of rot on the joists. Replacement may eventually be desired. In the interim, localized repairs could be undertaken.

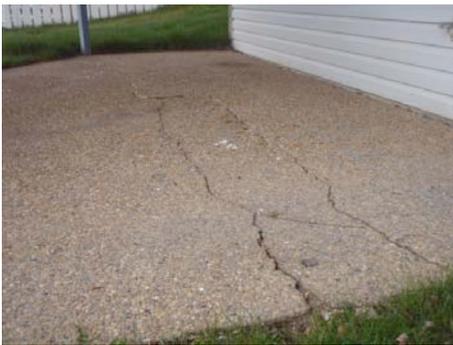
- **Possible Concern, Monitor:** The soil below the lower patio at the east side of the home has settled and/or heaved. Persisting movement may result in the need for resurfacing.

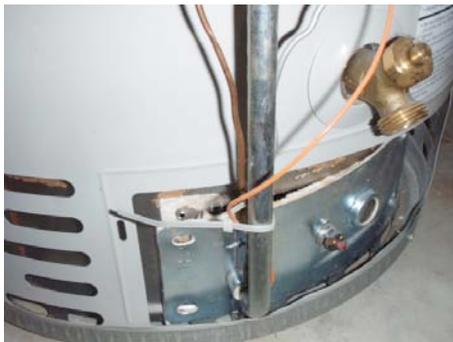
- **Repair:** It is recommended that the water heater be adjusted so the access panel and controller fit properly. The water heater is not lighting properly and will need to be repaired.

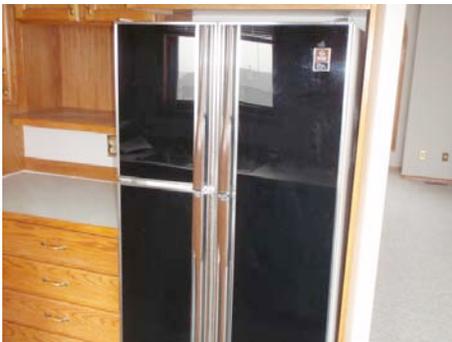
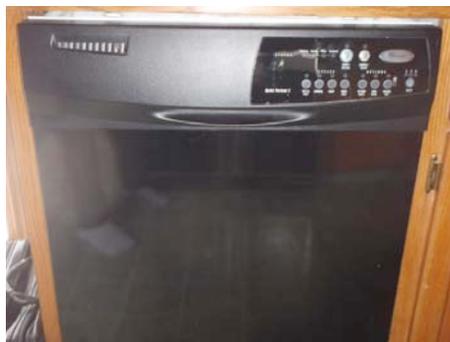
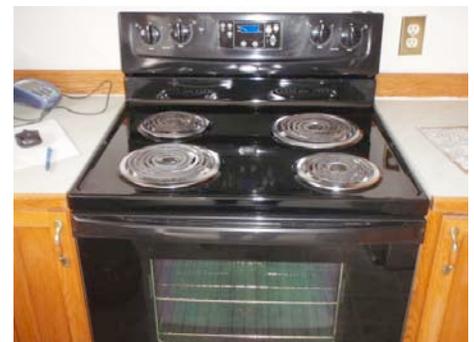
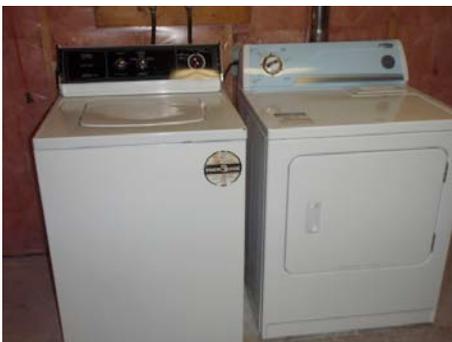
- **Monitor:** The refrigerator is an old unit. While replacement is not needed right away, it would be wise to budget for a new refrigerator. In the interim, a higher level of maintenance can be expected. The refrigerator is excessively noisy.
- **Repair:** The kitchen exhaust hood fan should have the plastic cover on the front removed. The removal of the plastic cover allows the air to circulate through the filters. If the fan is vented to the exterior the plastic cover is to remain so the airflow is directed outside.
