HOME SAFE & SOUND
Home Inspection

Building Inspection Report

#123 Your Address

Inspection Date:
May 10, 2010

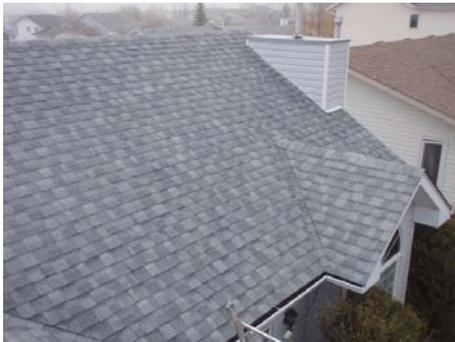
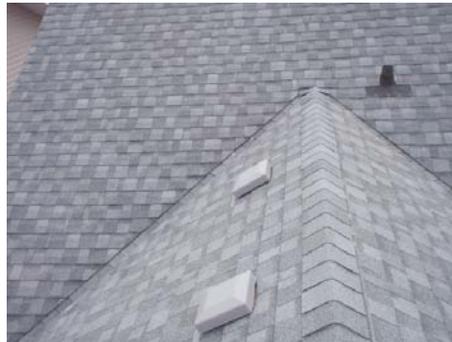
- **Monitor: Repair:** The roofing is in fair condition but has been installed using poor workmanship. While this condition does not pose a serious short-term concern, it risks leaks and shorter roof life. The starter row should be installed with the aggregate side up
- **Monitor: Repair:** The installation of the roofing system is such that several vulnerable areas may exist. There is a higher potential for leaks. The valleys have been installed a new way and may be vulnerable. Further investigation may be needed. Roofing installation must follow recommended standards approved by the Alberta building code

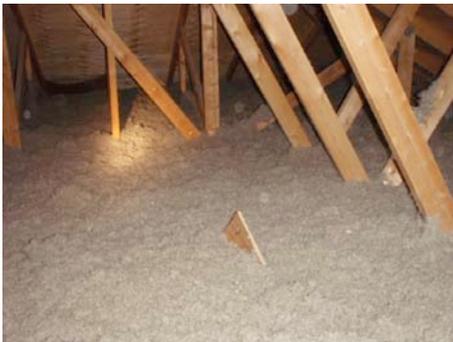
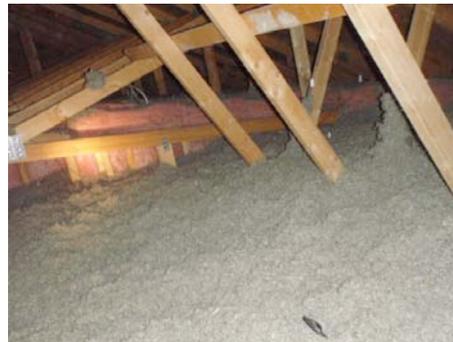
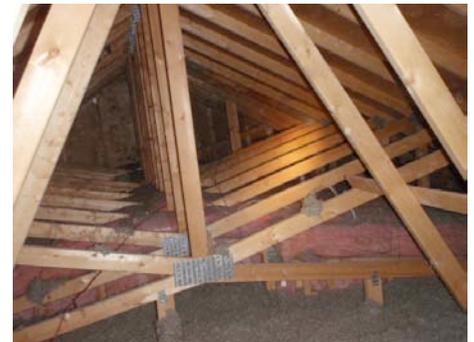
- **Improve:** The garage attic access hatch should be better insulated.
- **Improve:** The garage attic access hatch weather stripping needs to be improved. This will help reduce heat loss and the development of condensation around the hatch.
